# Midwest kiln baghouse rebuild

by Keith Gooch &  
Larry McConnell, GE, USA

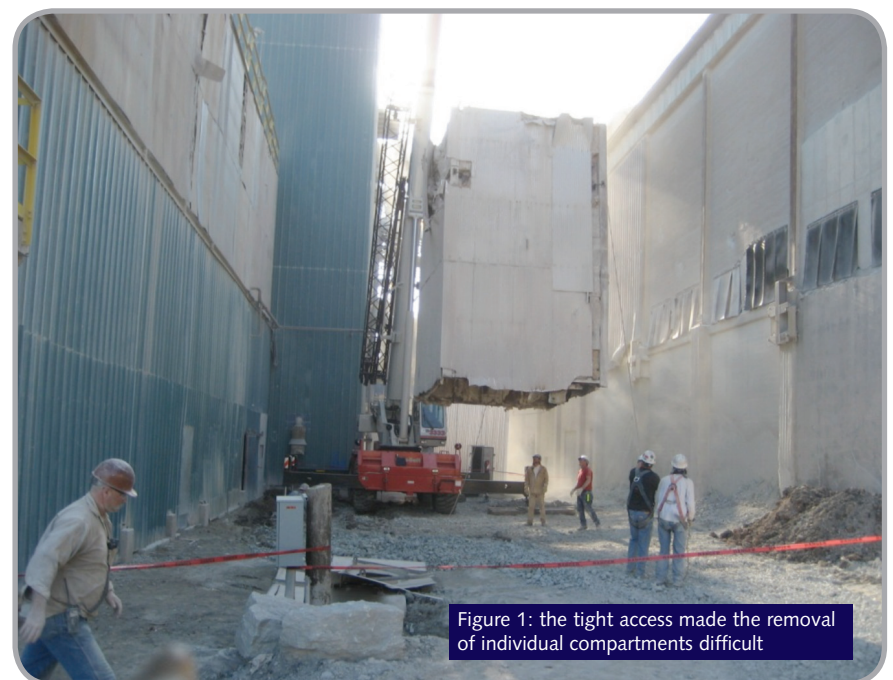
Figure 1: the tight access made the removal of individual compartments difficult

The only options for the kiln system were to either completely replace the collector with a new unit, or replace the compartments from the hopper upwards. Installing a new unit was out of the question because of the downtime it would require and the substantially higher cost. It was determined that the collector

would have to be repaired without disrupting the plant's production schedule. This meant replacing compartments one at a time while the collector remained in operation.

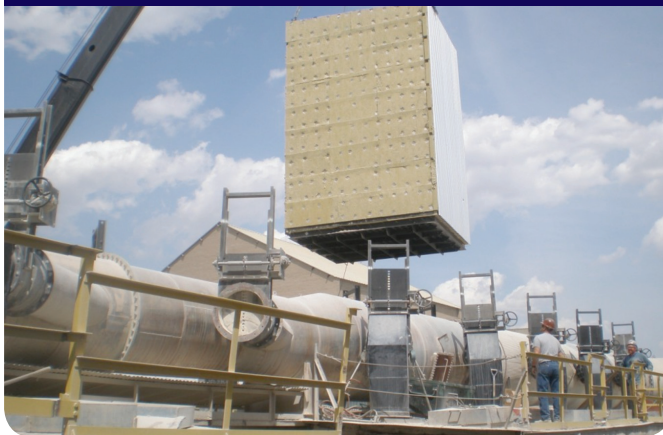
Figure 2: difficult crane access required 'flying' half of the compartments over the on-line system. Careful planning and close co-ordination were required to assure the compartment change-outs went smoothly

Logistics proved to be the most difficult aspect of the overall project. Online equipment modifications require significant planning and coordination of the manufacture and shipment of the equipment, or else there would be breaks in the workflow. The lay down area was small and allowed only one new compartment at a time to be received and worked on. There was very little room to unload the equipment and leave available room for the insulation crews to do their work. At the same time, room was required for the demolition of the existing compartments. The kiln unit was in a relatively long narrow area that allowed crane access from only one side of the 16-compartment system. To remove and install seven of the 14 compartments, the crew had to lift the replacement modules over the operating equipment.

Difficult crane access required 'flying' half of the compartments over the on-line system. Careful planning and close co-ordination were required to assure the compartment change-outs went smoothly.
